Appendix E – Ground Investigation Report

RE: Land to the rear of Culham Science Centre, Culham, Abingdon, OX14 3DB - Letter Report

Appendix F - Greenfield Runoff Rate

Appendix G – Conceptual Drainage Strategy

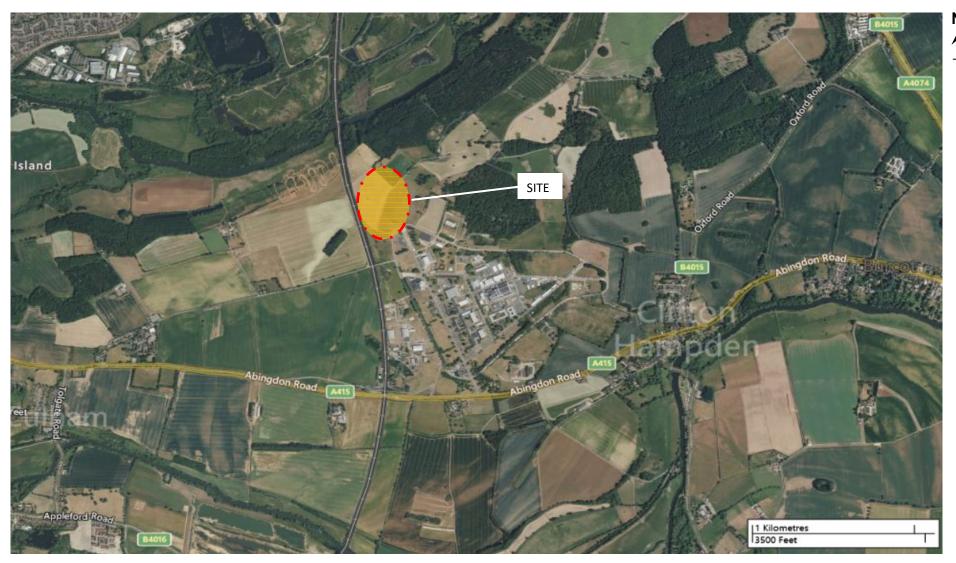
Site Location Plan

Project:	Culham, Abingdon			Title
Client:	Statera Energy			
Ref No:	GE21162	Version:	0.0	
Drawn:	SA	Date:	05/10/2022	
Figure:	1	Scale:	Not To Scale

Further to your instruction, we write to present the findings of the intrusive investigation undertaken at land to the rear of Culham Science Centre, Culham, Abingdon, OX14 3DB (Figure 1).

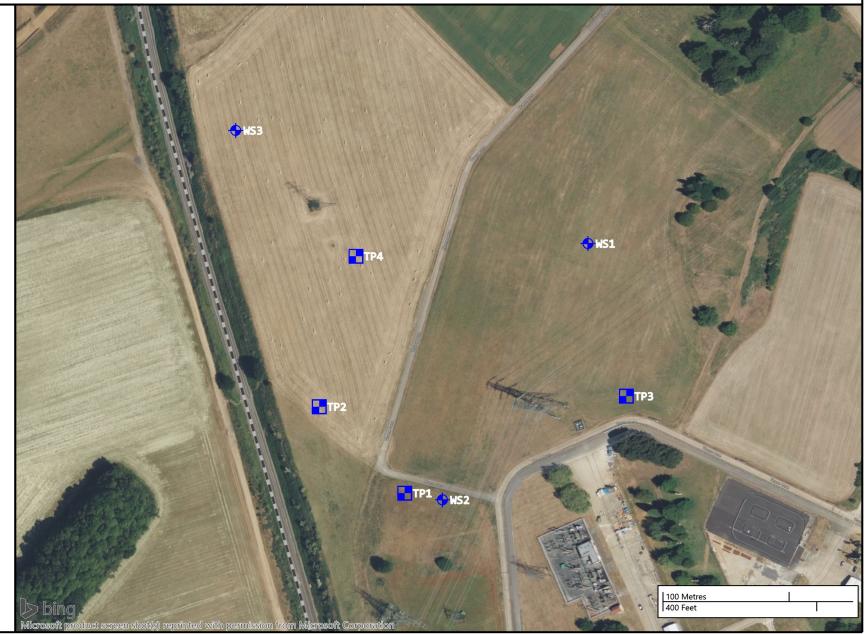
Title: Figure 2 - Exploratory Hole Location Plan

Locations By Type - Empty

Locations By Type - TP

Locations By Type - WLS

The intrusive investigation was carried out on 27th, 28th and 29th September 2022. The positions were agreed with the Client but adjusted on site to avoid overhead and underground utilities. The locations of the exploratory holes are shown on Figure 2.

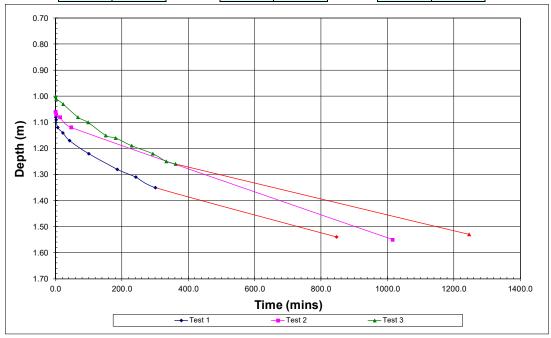
Pit reference	TP1		
Test reference	Test1	Test2	Test3
Pit depth (m)	1.70	1.70	1.70
Pit width (m)	0.45	0.45	0.45
Pit length (m)	1.70	1.70	1.70
Depth to standing water (m)

Max. depth (m)	1.70	1.70	1.70
Effective depth (m)	0.64	0.64	0.70
75% effective depth (m)	1.22	1.22	1.18
50% effective depth (m)	1.38	1.38	1.35
25% effective depth (m)	1.54	1.54	1.53
t75 (min)	100.00	270.00	220.00
t50 (min)	380.00	630.00	660.00
t25 (min)	847.00	1015.00	1246.00
Vp 75-25	0.24	0.24	0.27
ap 50	2.141	2.141	2.27
tp 75-25	747.00	745.00	1026.00

Soil infiltration rate (m/s) 2.6E	2.6E-06	1.9E-06
Soil infiltration rate (mm/hr) 9.18E-	9.21E+00	6.90E+00

- Blue cells require input data Infiltration calculated to method in 'BRE Digest 365 (1991) Soakaway Design' First line of table must be depth at time = 0 Extrapolated data shown in red
- 1 2 3 4

The results of the testing are summarised in Table 2 below. The soakage test results are included within Appendix B. In trial pits TP1 and TP3 Test 1 was abandoned, and Test 2 commenced at the end of the first day of testing when it became apparent that Test 1 would conclude during the night when accurate measurement would not be possible.

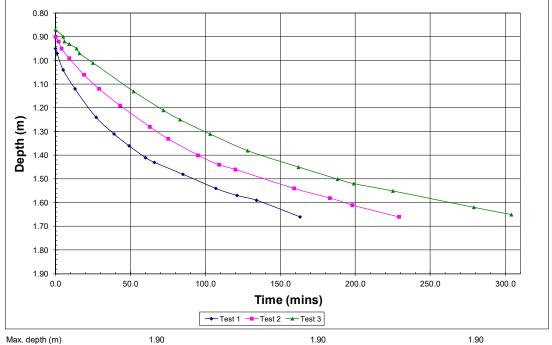
Pit reference	TP2		
Test reference	Test1	Test2	Test3
Pit depth (m)	1.90	1.90	1.90
Pit width (m)	0.45	0.45	0.45
Pit length (m)	1.30	1.30	1.30
Depth to standing water (m)

Max. depth (m)	1.90	1.90	1.90
Effective depth (m)	0.95	1.00	1.03
75% effective depth (m)	1.19	1.15	1.13
50% effective depth (m)	1.43	1.40	1.39
25% effective depth (m)	1.66	1.65	1.64
t75 (min)	20.00	35.00	52.00
t50 (min)	66.00	95.00	135.00
t25 (min)	163.00	220.00	295.00
Vp 75-25	0.28	0.29	0.30
ap 50	2.2475	2.335	2.3875
tp 75-25	143.00	185.00	243.00

Soil infiltration rate (m/s) 1.4E-	5 1.1E-05	8.7E-06
Soil infiltration rate (mm/hr) 5.19E+	4.06E+01	3.12E+01

- Blue cells require input data Infiltration calculated to method in 'BRE Digest 365 (1991) Soakaway Design' First line of table must be depth at time = 0
- 1 2 3

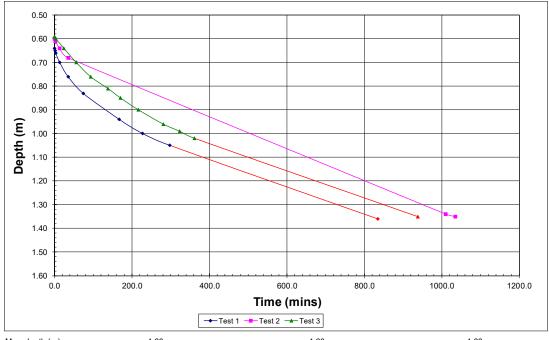
Pit reference	TP3		
Test reference	Test1	Test2	Test3
Pit depth (m)	1.60	1.60	1.60
Pit width (m)	0.45	0.45	0.45
Pit length (m)	1.60	1.60	1.60
Denth to standing water (m)

Max. depth (m)	1.60	1.60	1.60
Effective depth (m)	0.96	1.00	1.01
75% effective depth (m)	0.88	0.85	0.84
50% effective depth (m)	1.12	1.10	1.10
25% effective depth (m)	1.36	1.35	1.35
t75 (min)	190.00	290.00	160.00
t50 (min)	250.00	520.00	500.00
t25 (min)	835.00	1035.00	938.00
Vp 75-25	0.35	0.36	0.36
ap 50	2.688	2.77	2.7905
tp 75-25	645.00	745.00	778.00

Soil infiltration rate (m/s)	3.3E-06	2.9E-06	2.8E-06
Soil infiltration rate (mm/hr)	1.20E+01	1.05E+01	1.00E+01

- 1 2 3 4
- Blue cells require input data Infiltration calculated to method in 'BRE Digest 365 (1991) Soakaway Design' First line of table must be depth at time = 0 Extrapolated data shown in red

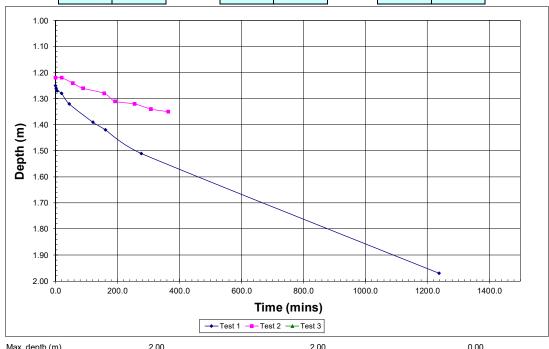
Pit reference	TP4		
Test reference	Test1	Test2	Test3
Pit depth (m)	2.00	2.00	
Pit width (m)	0.45	0.45	
Pit length (m)	1.40	1.40	
Depth to standing water (m)

Max. depth (m)	2.00	2.00	0.00
Effective depth (m)	0.75	0.78	0.00
75% effective depth (m)	1.44	1.42	0.00
50% effective depth (m)	1.63	1.61	0.00
25% effective depth (m)	1.81	1.81	0.00
t75 (min)	180.00		
t50 (min)	530.00		
t25 (min)	900.00		
Vp 75-25	0.24	0.25	0.00
ap 50	2.0175	2.073	0
tp 75-25	720.00	0.00	0.00

Soil infiltration rate (m/s)	2.7E-06	
Soil infiltration rate (mm/hr) 9.7	76E+00

- Blue cells require input data Infiltration calculated to method in 'BRE Digest 365 (1991) Soakaway Design' First line of table must be depth at time = 0

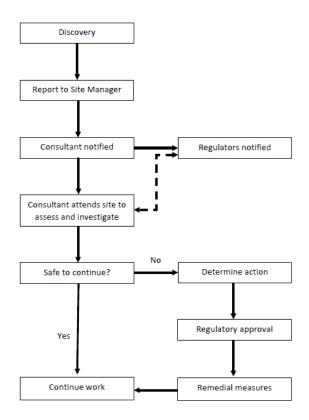
The process is summarised below:
