The Nuneham Estate

Parkland Management Plan

Appendix B: Archaeology & Heritage Report
by BSA Heritage

Archaeology & Heritage Report

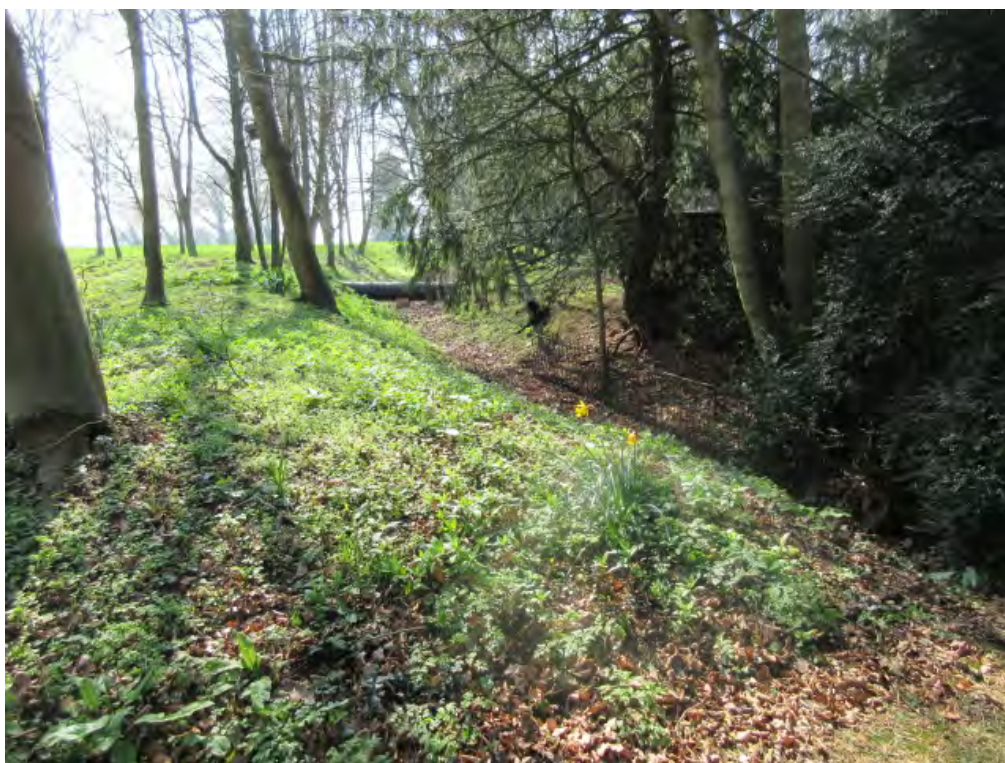
Plate 1: Holloway south of Nuneham House, looking south

- 2.16 South of the new house, a linear feature on Brown's Hill has the appearance of a section of holloway and runs on a north south alignment which would make it a possible 'Abingdon Road' to old Nuneham (Site 23, Plate 1). It may be post-medieval and related to a park ride or boundary though.

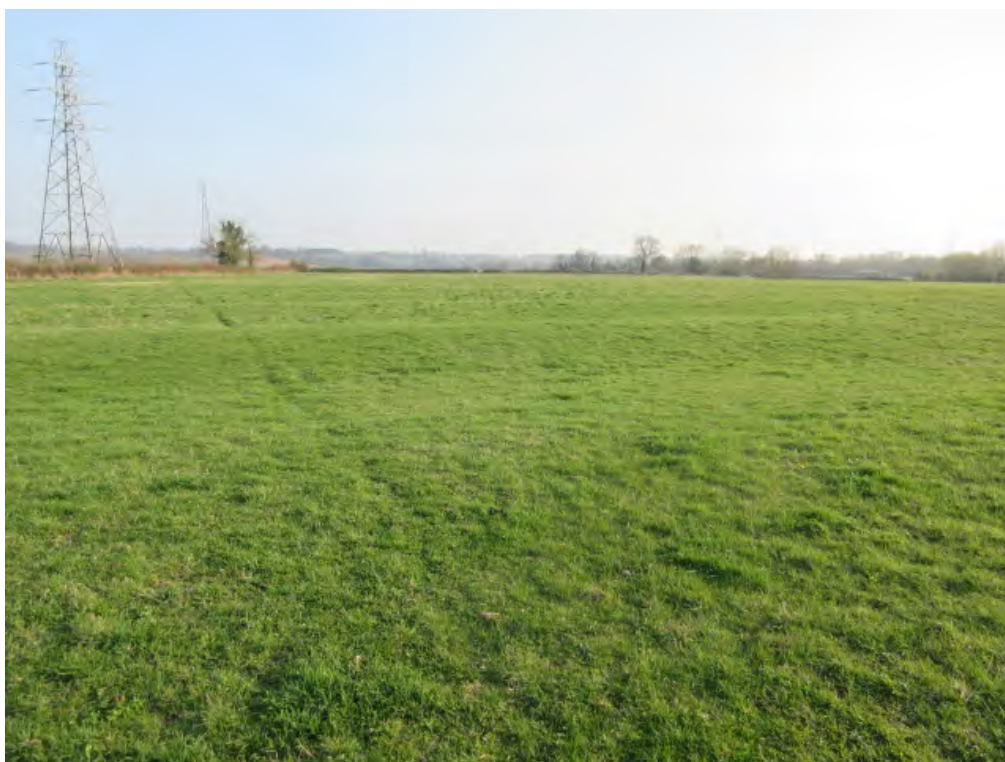
Plate 2: Ridge and furrow south of Lower Farm, looking south

- 2.17 In the north of the site, the last definite vestiges of ridge and furrow marking Nuneham's medieval open field system runs east west south of Lower Farm (Site 2, Plate 2). Aerial photographs confirm that, post-war, the ridge and furrow survived much more extensively north of the park, but as elsewhere, modern cultivation techniques have removed almost all of it, including some within the pasture field in which what remains lies.

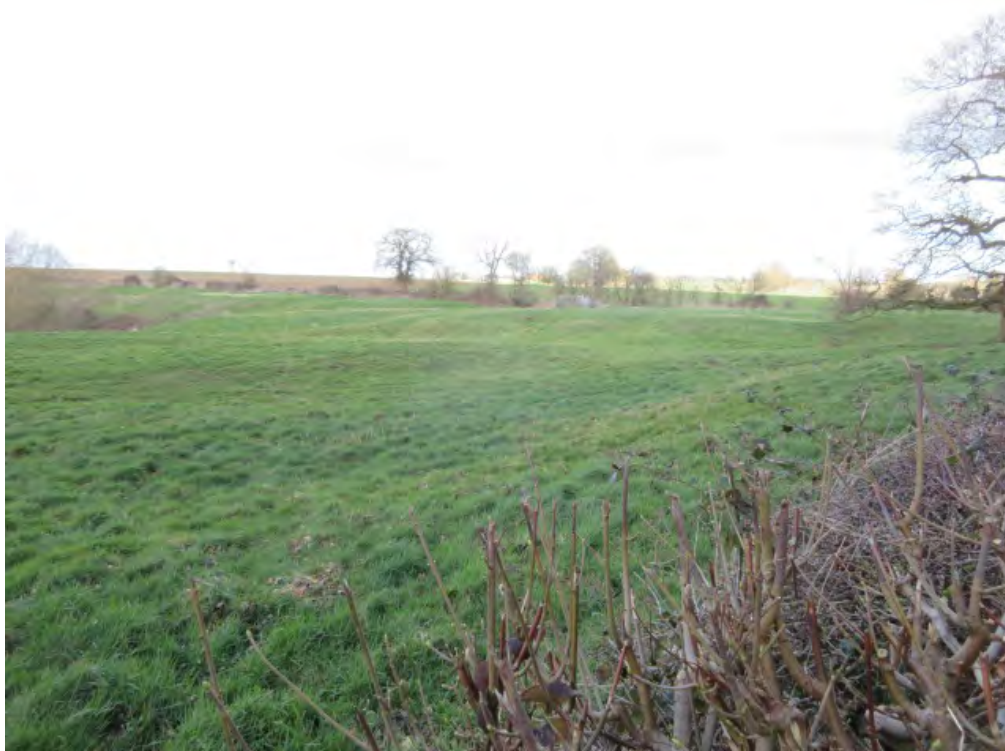
Plate 3: Earthworks east of The Rectory, looking north west

- 2.18 North east of Nuneham House, and also under permanent pasture, enigmatic earthwork features may also be the vestigial remains of ridge and furrow or of partial tracks (Sites 6 & 7). Site 6 relates to one or perhaps two 'lynchet' type cultivation terraces on the steep side of a valley. Site 7 includes short stretches of ridges and also a likely former quarry which is now being damaged by vehicle tracks (Plate 3).

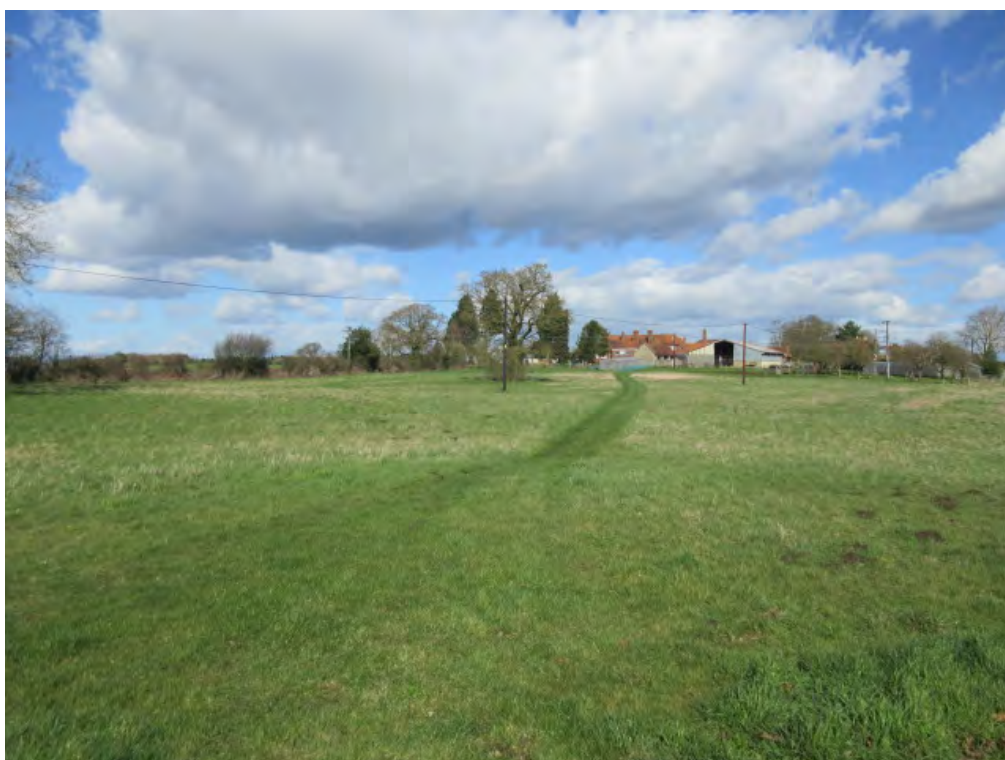
Plate 4: Faint earthworks west of Nuneham Courtenay (new), looking east

- 2.19 Closer to the new Nuneham arrayed along the main road (a former turnpike) east of the site are other earthwork features under pasture (Site 9, Plate 4). As the settlement only moved to this location in the later 18th century, it is most likely that these features and an adjacent pond which may have been a quarry are of this or later date.

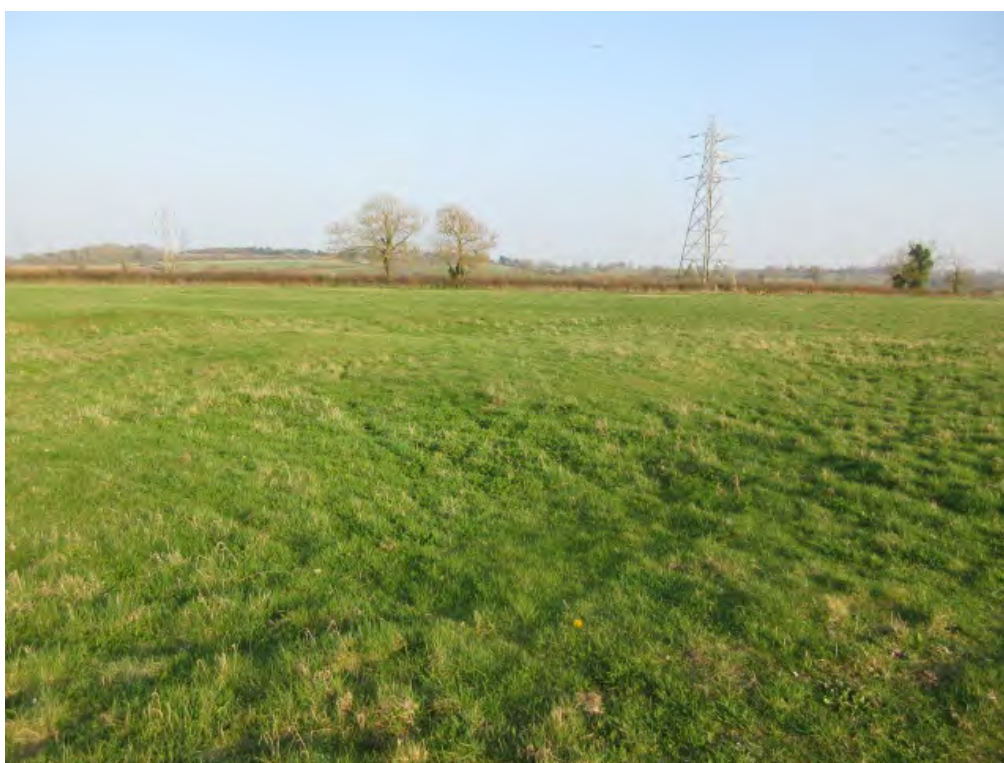
Plate 5: Earthworks south of Lower Farm, looking south east

- 2.20 The majority of later features relate to the park created by the 1st Lord Harcourt in the second half of the 18th century. Possibly earlier than that and other than the earthworks mentioned above are the likely site of farm buildings and a pond south of the extant and listed Lower Farm converted barn and farmhouse (Site 1). These earthworks are later than the ridge and furrow and look to include platforms which may equate to demolished structures or where they lay (Plate 5).

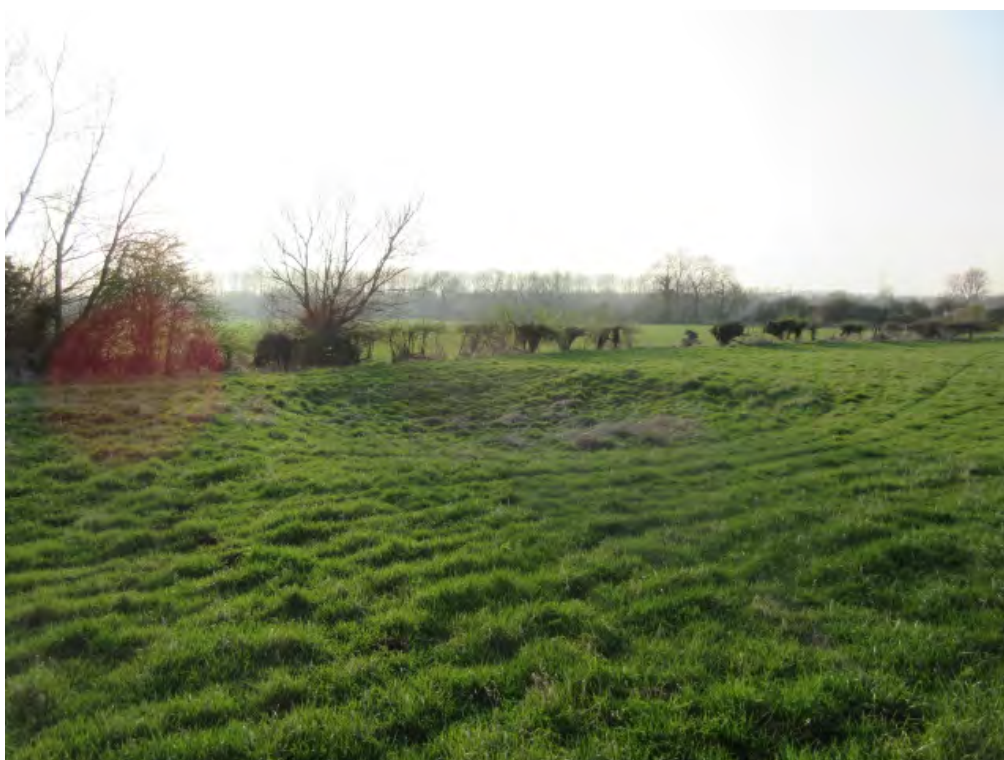
Plate 6: Small pond south of Lower Farm, looking west north west

- 2.21 South west of these and in the same field, a small circular depression is likely may have been a related dew pond (Site 3, Plate 6). Site 13 is not located, but relates to the names 'Windmill Field' and 'Windmill Hill' which indicate the historical location of such a structure. However, once removed, little might survive of a timber framed post mill, ploughing might obliterate a low mill mound and the highest ground for a mill lies east of the site itself.

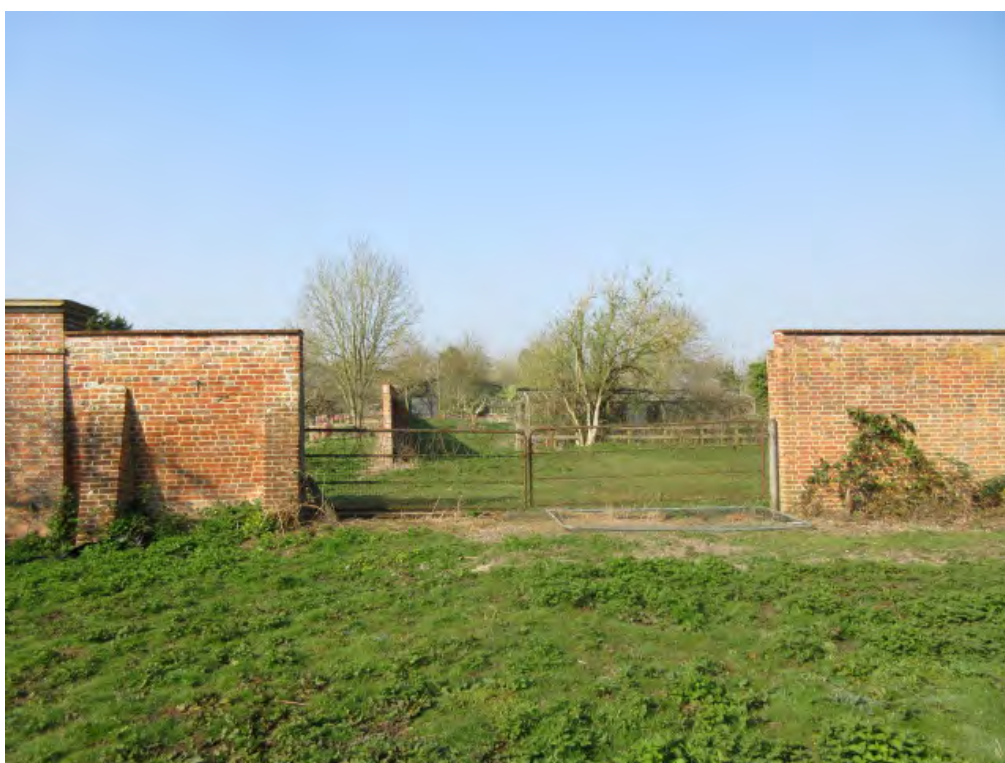
Plate 9: View west into kitchen gardens

- 2.26 Related to the park and included within the site is an extensive kitchen garden to its north east (32, Plate 9). Although not listed in its own right, an ornate gateway to the east is, and it might be argued that the connected walls and wider garden are therefore curtilage listed (16, Plate 10). The walls of this 18th century garden look to have been repointed in places, although repair would be useful in other areas. A late 20th century book repository fills up much of the southern garden. Elsewhere there is some planting and disused greenhouses, although the open areas and some internal structures in the north are slightly forlorn in appearance.

- 3.3 Kitchen garden walls also appear to have been partially repointed, although other stretches of wall could benefit from appropriate intervention. The converted residences surrounding the garden all appear to be in good order, although removal of vegetation from the surviving elevations of the mainly demolished stables is advisable.

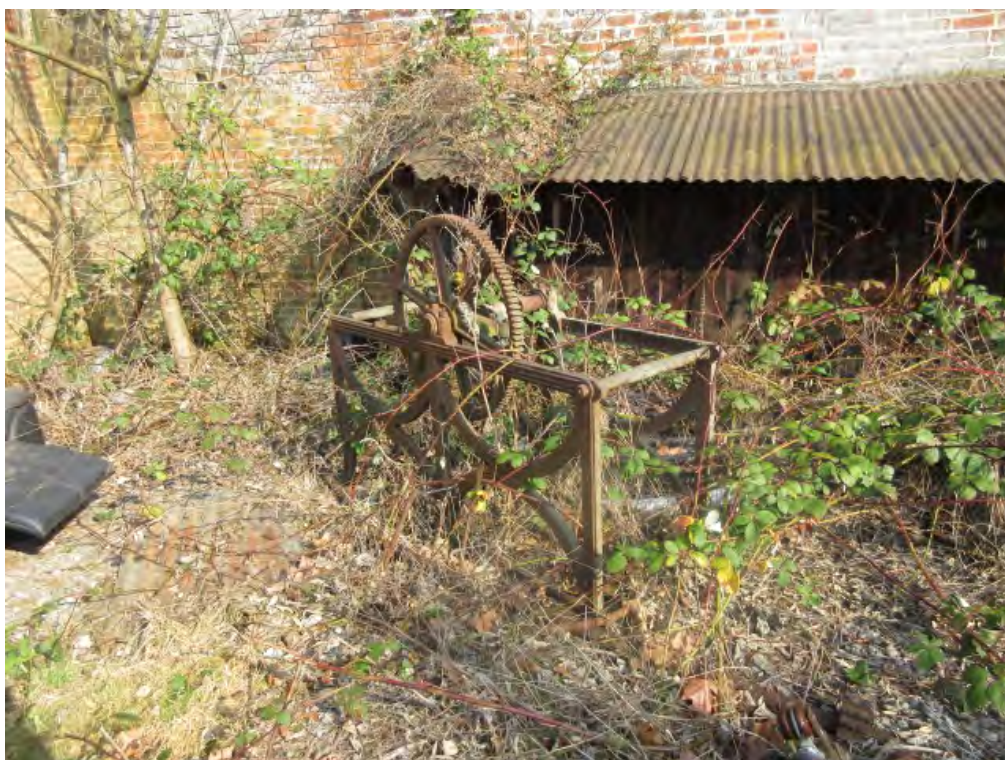
- 2.27 There is no sign of a well recorded by the HER and likely to have lain just within the garden close to the listed gateway. The HER entry notes that this had horse powered headgear which, in 1973, was set to be scrapped. However, a fine cast iron mechanism was noted north of the gateway which appears to be what once lay above the well (16, Plate 11).

Plate 11: 18th century pump headgear

- 3.12 The unexpected survival on site of the well headgear is positive. However, it currently lies close to an estate road and next to a refuse skip. It could be removed relatively easily and this should be moved as a priority where it is more secure. Ideally it would also be stored in a dry space where it will not deteriorate. Reinstatement within the kitchen garden might be considered in due course, with a capital payment possibly available for interpretation and enclosure.

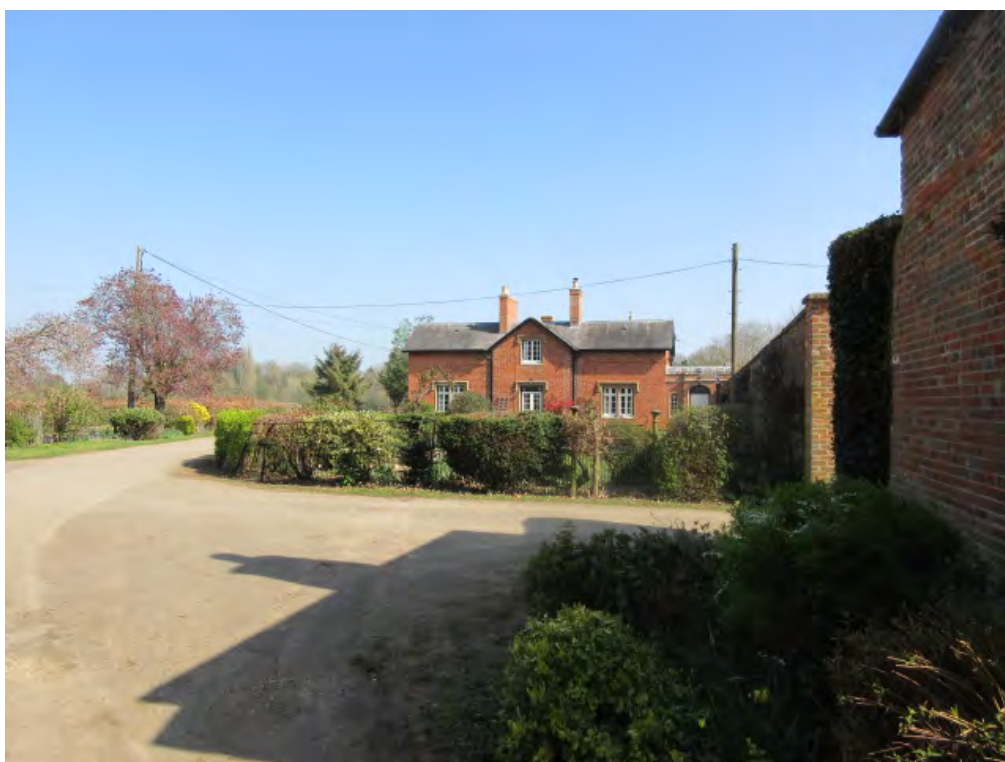
- 2.28 To the north of the kitchen garden lie a range of predominantly brick agricultural structures and two residences of Home Farm. These are likely to be 19th and 20th century in origin and the agricultural buildings appear to be little used, but all are in good condition (Plate 12).

Plate 12: Home Farm looking east

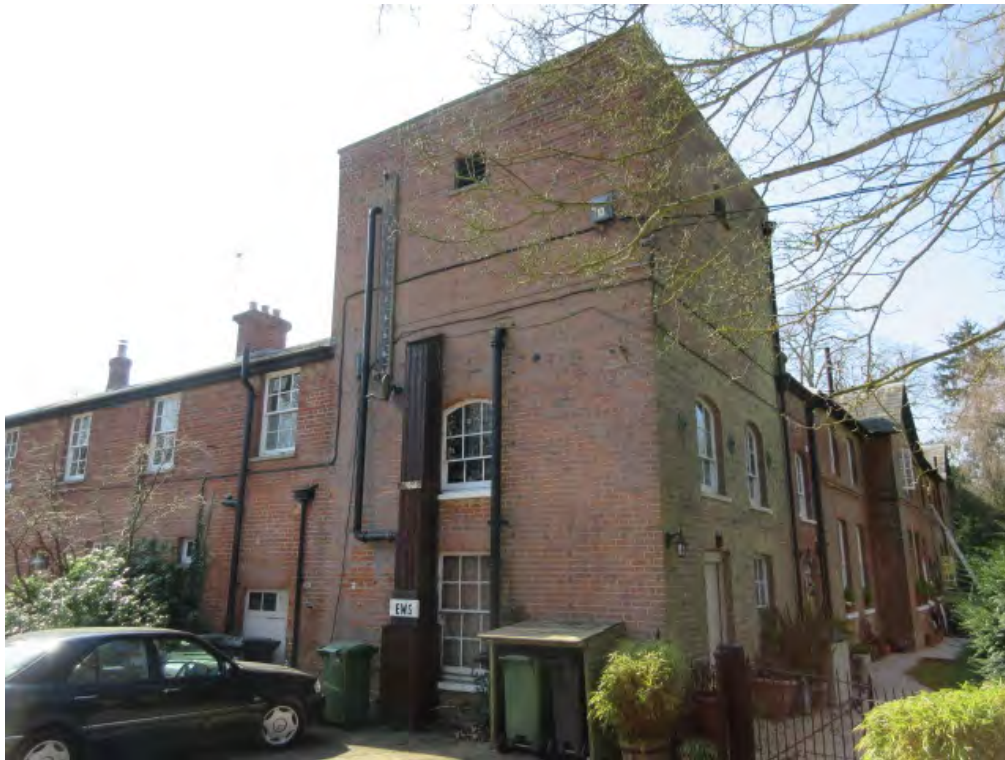
Plate 13: Water tower forming part of converted coach house west of kitchen garden

- 2.29 On the west side of the kitchen garden are further brick buildings now mainly converted to residential use and in a good state of repair. They include the Grade II listed Dairy Cottage and also a water tower incorporated into a former coach house block (Plate 13). South of this, two southern elevations of the original 18th century stable block survive incorporated into much later structures (33, Plate 14).

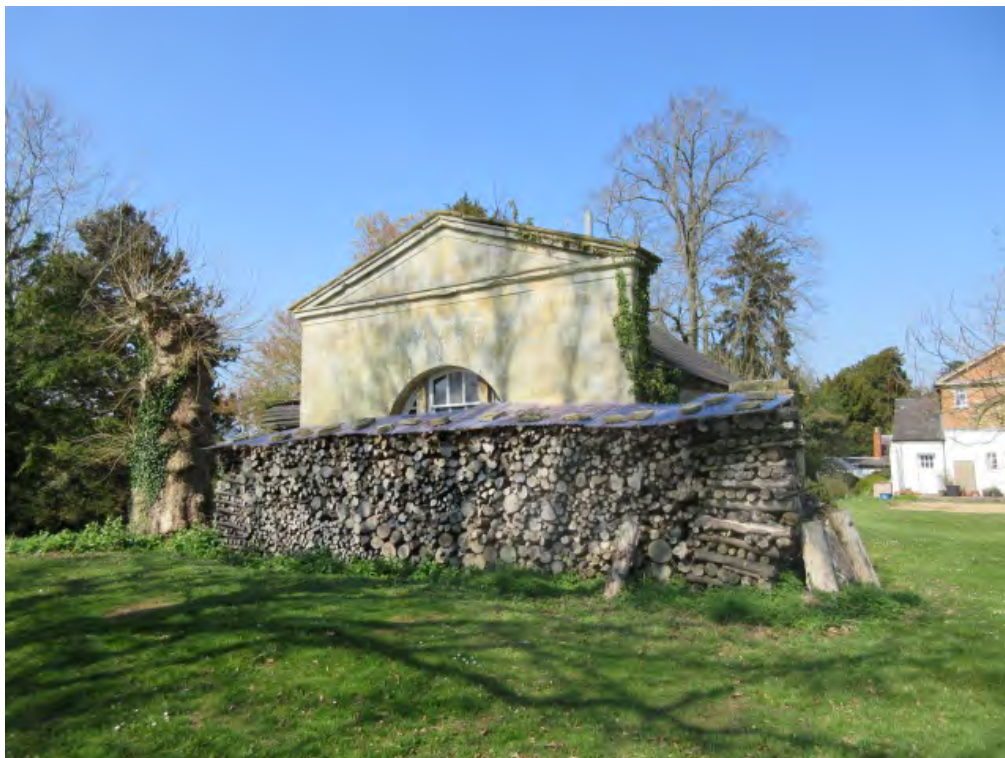
33/13341	Stables	5424 9818	18 th century	Stable	Low	Poor	National*	Southern end walls of late 18 th century stable block survive and have been incorporated in later structures. Hinges and gate piers also survive.
34/16927	Iron Age pit	5402 0012	Iron Age	Slow deterioration	Medium	Uncertain	Local	Found during pipeline works. Indicates more extensive remains relate to kiln site to north.
35/16928	Roman pit	5439 0048	Roman	Slow deterioration	Medium	Uncertain	Local	Found during pipeline works. Indicates more extensive remains relate to kiln site to west.
36/1430	Implement findspot	5336 0033	Bronze Age	N/a	N/a	N/a	Local	Find within site confirms background prehistoric potential.

Plate 14: Surviving southern end of 18th century stable block

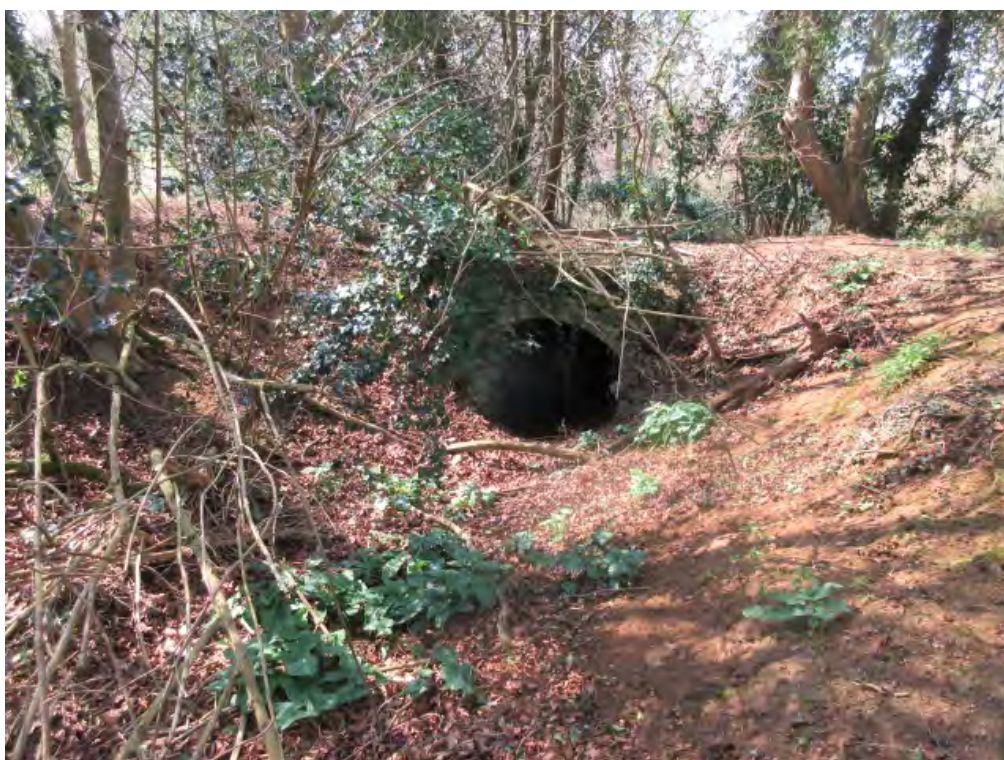
18	Ox Tunnel	5420 9849	18 th century	Slow deterioration	Medium	Fair	National*	Tunnel to lead cattle around park now silted up, some loss to facing brick and stonework and danger from animal burrows and scrub.
19	Cropmark	5385 9818	20 th	N/a	Medium	Poor	N/a	Unusual cropmark feature evident on 2000 obliques, but not

Plate 16: East end of Ox Tunnel

- 3.2 Most park features are in good condition and appear well managed. In particular, structures are well maintained, although there is limited evidence of burrowing at the Ox Tunnel and Venison House (18 & 25, Figure 1). The Venison House appears to have benefited from recent restoration with new thatch, repointed brick base and painted weatherboarding. It is likely that the renewed thatch will provide better protection for the vulnerable metal grilles henceforward.

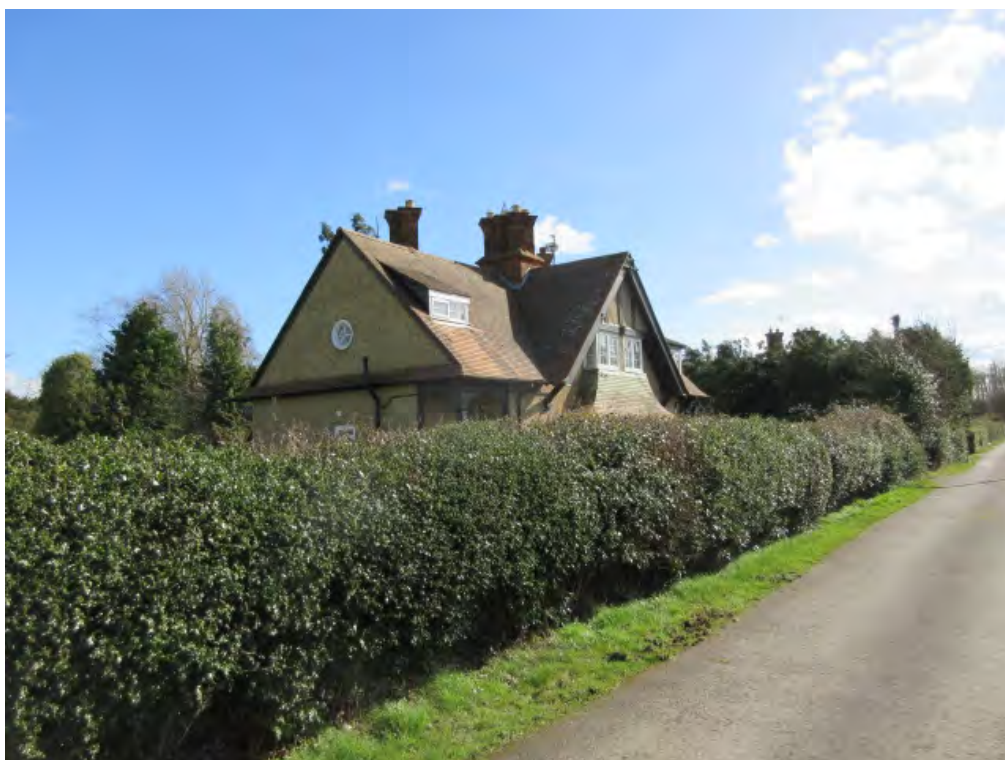
Plate 18: Latest Church of All Saints, looking north

- 2.30 North of the kitchen garden and Home Farm complex, features within the site which relate to the 18th century park include The Lake to the north east and an Ox tunnel which provided a route for cattle movement beyond the designed landscape (11 and 18, Plates 15 & 16). North of The Lake lie the late 19th century 'Village Lodge' and inter-war 'Park Cottages' to its south (12, Plate 17). Closer to new Nuneham lie the late 19th century new All Saints Church and 'Church View Cottages' (8 & 10, Plates 18 & 19). All are fine buildings in good repair, but none are listed.

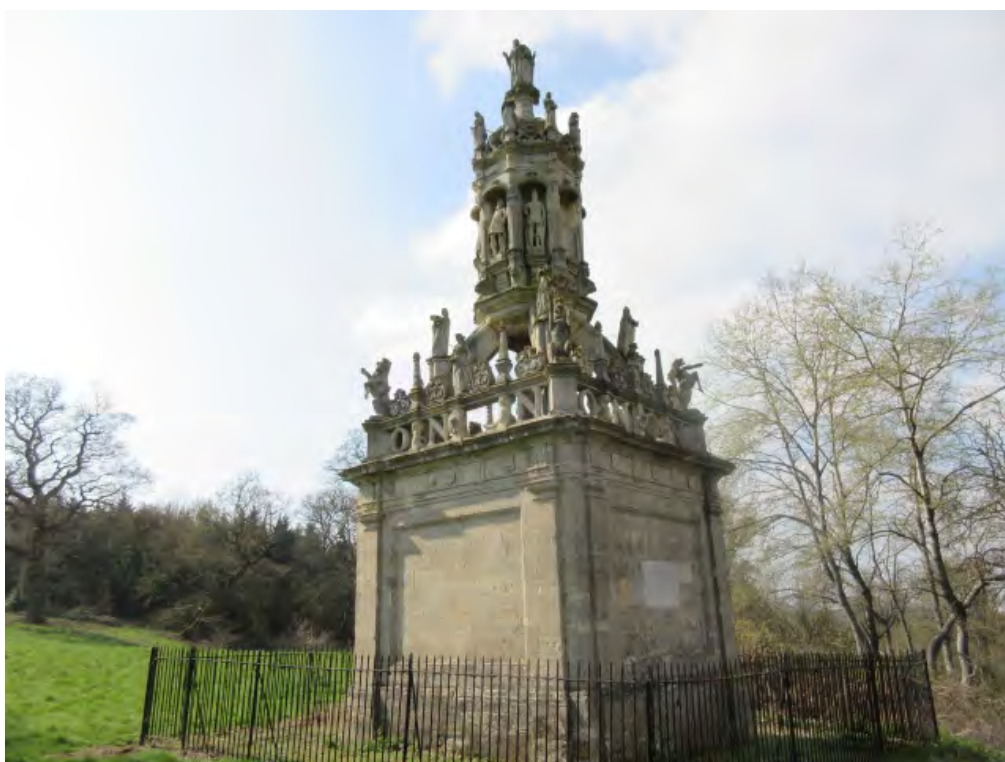
- 2.31 In the south of the site area, the early 17th century Carfax Conduit is Grade I listed and also a Scheduled Monument (28, Plate 20). It was moved from Oxford city centre to the park in the late 18th century to provide an eyecatcher south of the house. In the south east corner of the site area, 25 marks the site of the Grade II listed Venison House, a rare example of this type of structure (Plates 21 & 22). It has recently been restored. Historic 19th century maps confirm the park kennels once lay south west of the Venison House and the grade II listed 'Keeper's Cottage' which is excluded from the site area (Plate 23).

Plate 20: Carfax Conduit, looking south

deterioration				field boundary, this may be relatively recent.
28/3512	Carfax Conduit	537 976	17 th century	Stable	Low	Good	National	Grade I listed and scheduled structure likely to date to early 17 th century and was moved to Nuneham to act as eyecatcher in late 18 th century.
29/307	Lock and cottages	533 974	18 th century	Stable	Low	Poor	Local	Site of lock and cottages shown on historic maps, but no sign now, albeit likely outside of site.
30	Flint findspot	5380 9755	Prehistoric	Slow deterioration	Medium	Uncertain	Uncertain	Find made during investigation on water pipeline route. No indication of related activity.
31	Pottery findspot	5390 9750	Roman	Slow deterioration	Medium	Uncertain	Uncertain	Find made during investigation on water pipeline route. No indication of related activity.
32/	Walled garden structures	9423 9822	Post-medieval	Stable	Low	Good	National*	Numerous structures mainly now in residential use west and north of walled gardens include Home Farm buildings, coach house inc. water tower and Grade II listed Dairy Cottage (HER 13340). HER 410 refers to site of gasometer in south of area.

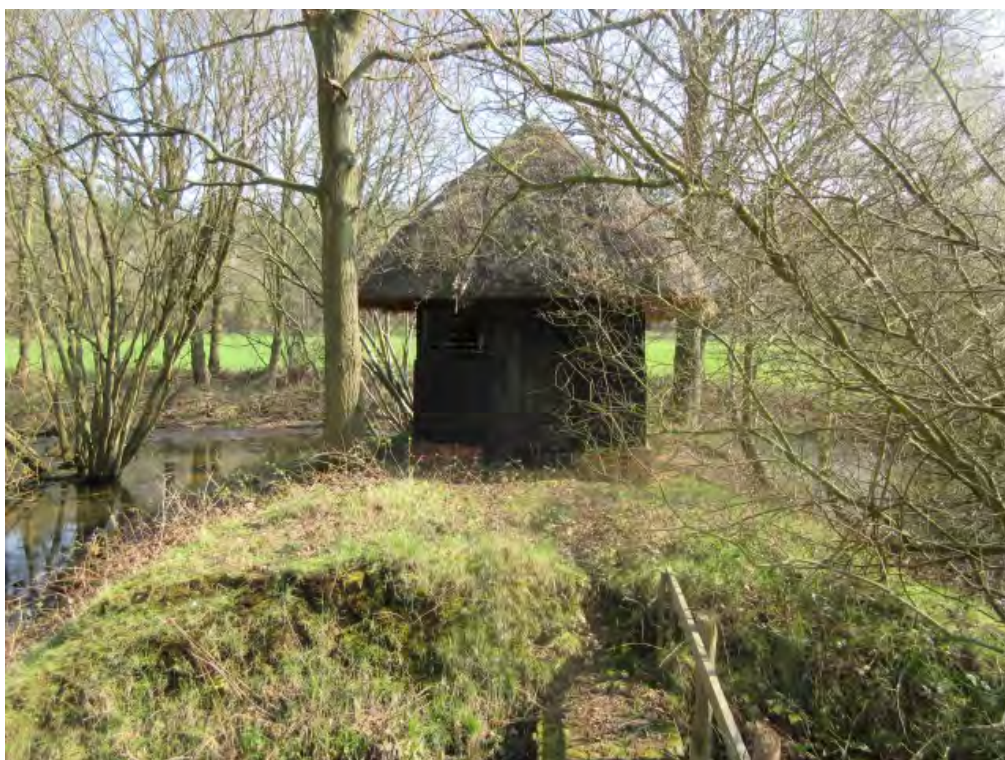
Plate 21: Venison House, looking east

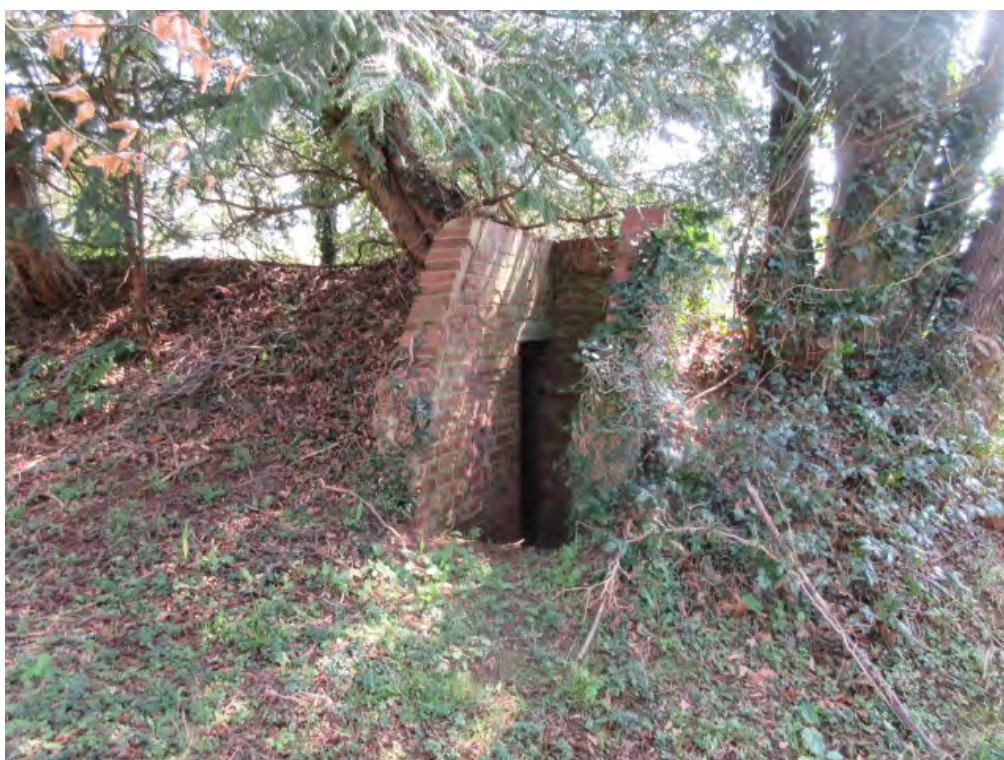
Plate 24: Air raid shelter (north side)

- 3.11 Nonetheless, needless removal of concrete roadways and the small number of surviving structures should be avoided where possible. In particular, the air raid shelter is in good condition and should be maintained (Site 22). It might in the future prove a good structure on which to focus interpretation of the Estate's wartime use.

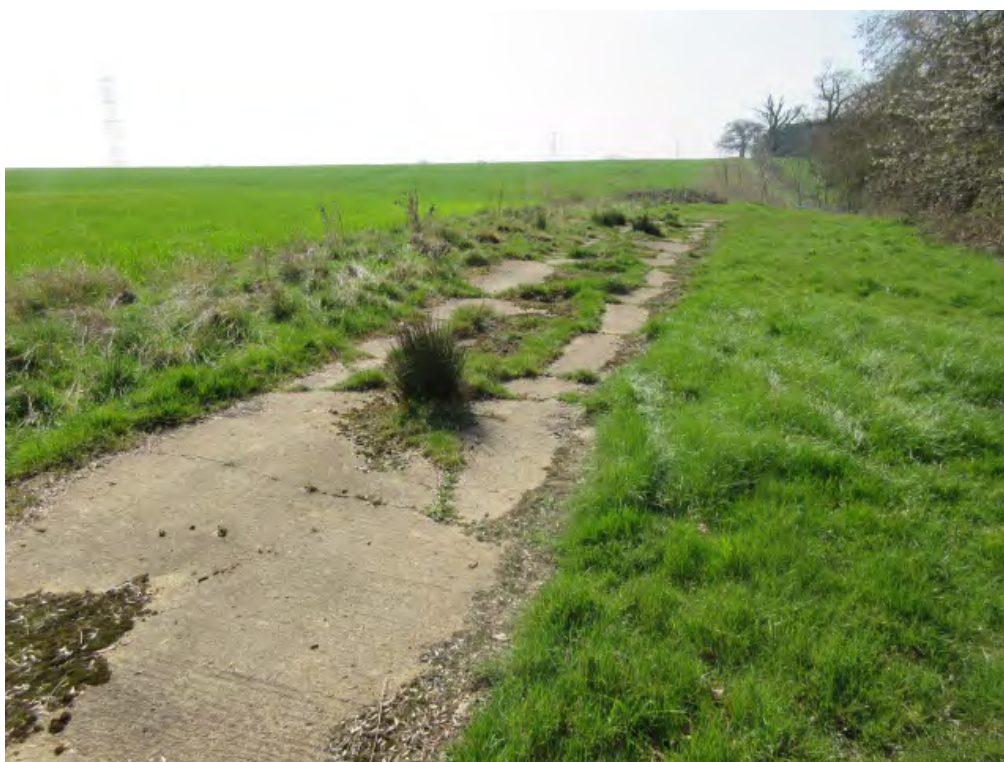
- 2.33 Very few remains relating to the Second World War use of the park now survive. Beyond the current site area, two small structures lie at the former sewage works. In a field east of the kitchen garden, piles of broken concrete are likely to be the remains of hut bases in this area. South west of the kitchen garden, an air raid shelter and likely wartime building also survive (22, Plates 24 & 25). East of Brown's Hill a section of track is likely to be contemporary (Plate 26).

Plate 26: Track east of Brown's Hill, looking south

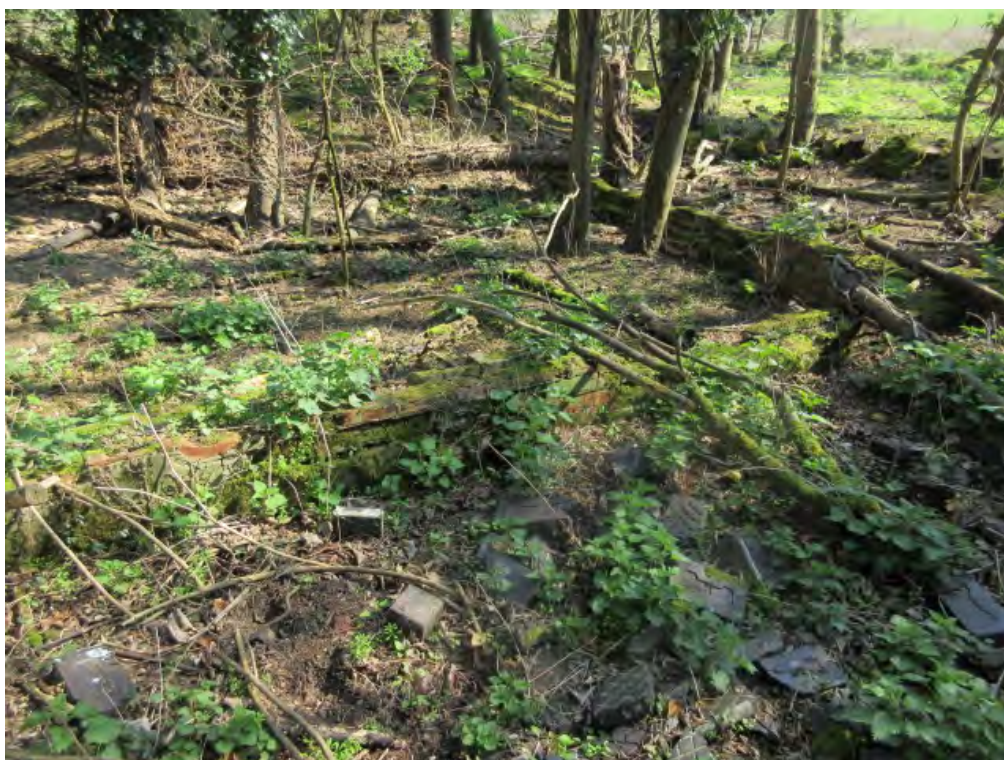
- 2.34 Site 14 relates to a small post-war copse which also contains fragmentary remains of Second World War structures including brick foundations and concrete surfaces (Plate 27). This area is also used to store architectural salvage which may be from Nuneham Park structures, but may also be from other Oxford University sites (Plate 28).

Plate 27: Military building remains south east of kitchen garden

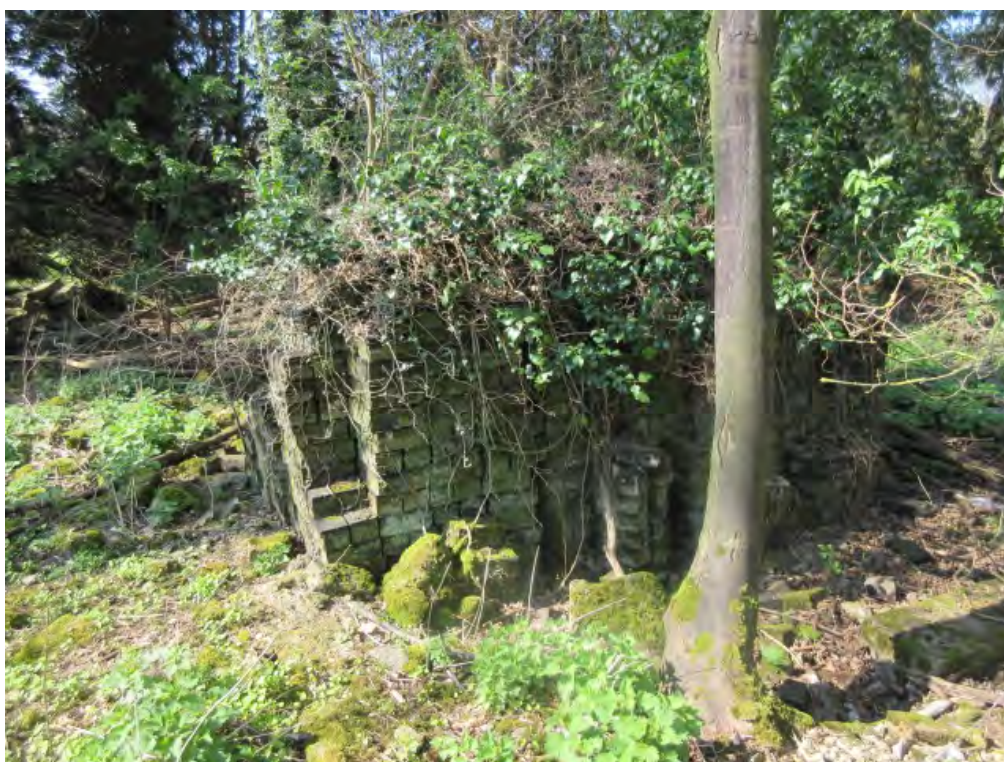
Plate 28: Pavilions stored in copse
